Manhole Inspection Summary

Manhole # S47I__039MH

Insp Date: **4/22/08 9:23 AM**

Location Address: **2230 bank st**

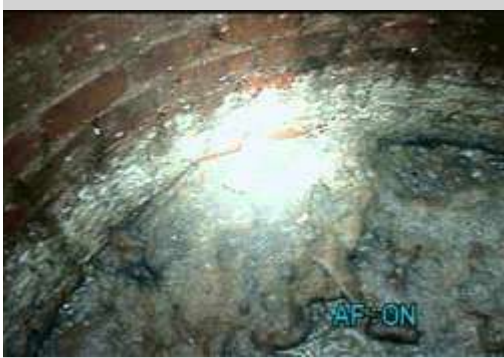
Defect 3

Condition: ☐ Sound ☐ Cracked ☐ Root Intrusion ☐ Deteriorated ☐ Leaks ☒ **Debris**

bench debris

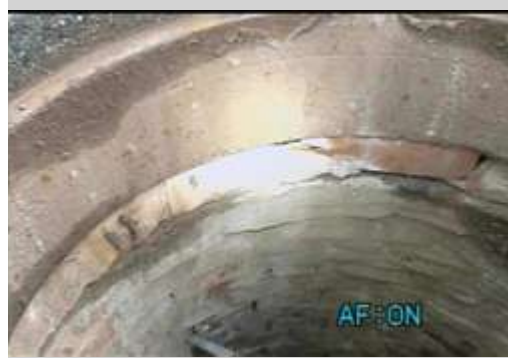
Defect 2

Offset: **2** (in.)

Condition: ☐ Sound ☐ Cracked ☐ Root Intrusion ☒ **Loose Brick** ☐ Deteriorated

chimney loose bricks, frame offset

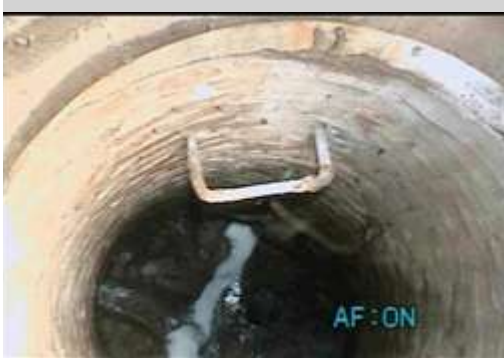
Defect 1

Condition: ☐ Sound ☐ Cracked ☐ Root Intrusion ☐ Deteriorated ☐ Leaks ☒ **Debris**

Count: **4** Missing: **0** ☒ **Corroded**

corroded steps, channel debris

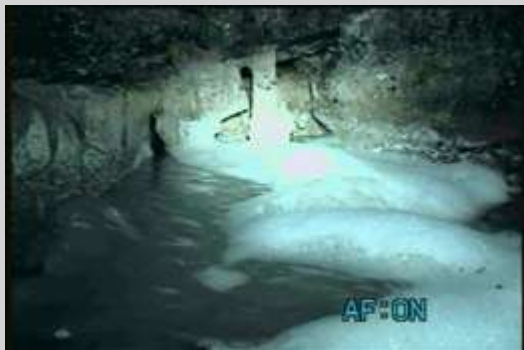
12 O'Clock Outflow

Deposits: ☐ None ☐ Mud ☐ Sludge ☒ **Debris** ☐ **Grease**

Silt Depth: 7 (in.) Deposits Extent: **Heavy**

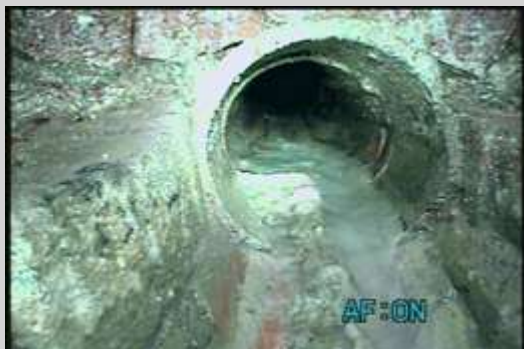
3 O'Clock Inflow

Deposits: ☐ None ☐ Mud ☐ Sludge ☐ Debris ☒ **Grease**

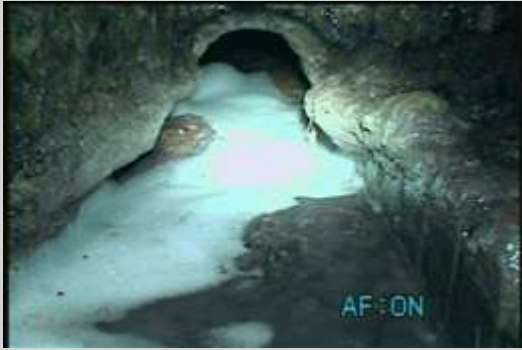
6 O'Clock Inflow

& channel debris

Deposits: ☐ None ☐ Mud ☐ Sludge ☐ Debris ☒ **Grease**
